Moisture Problems in Manufactured Housing: Probable Causes and Cures

Neil Moyer David Beal David Chasar Janet McIlvaine Chuck Withers

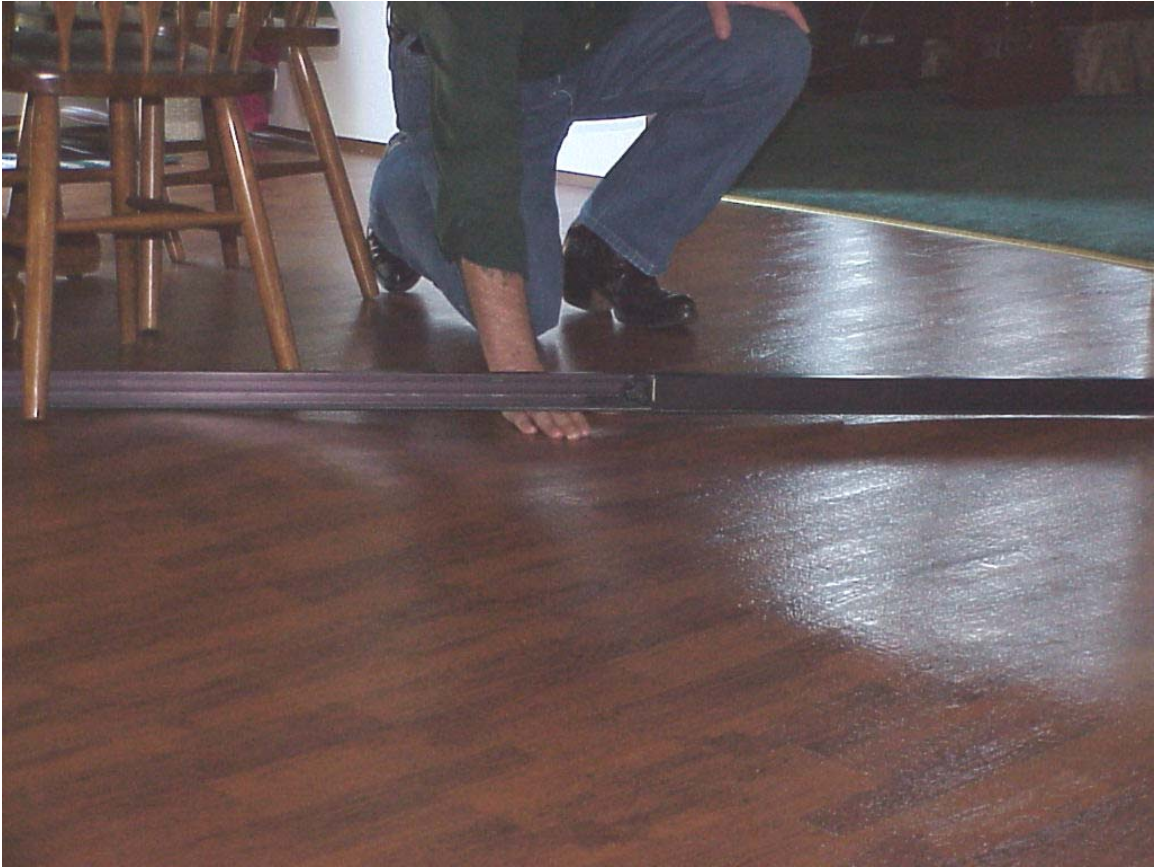
Figure 4 This home is experiencing a buckled floor problem. The subfloor is a HUD code approved composite wood product that has taken on moisture from the crawlspace.

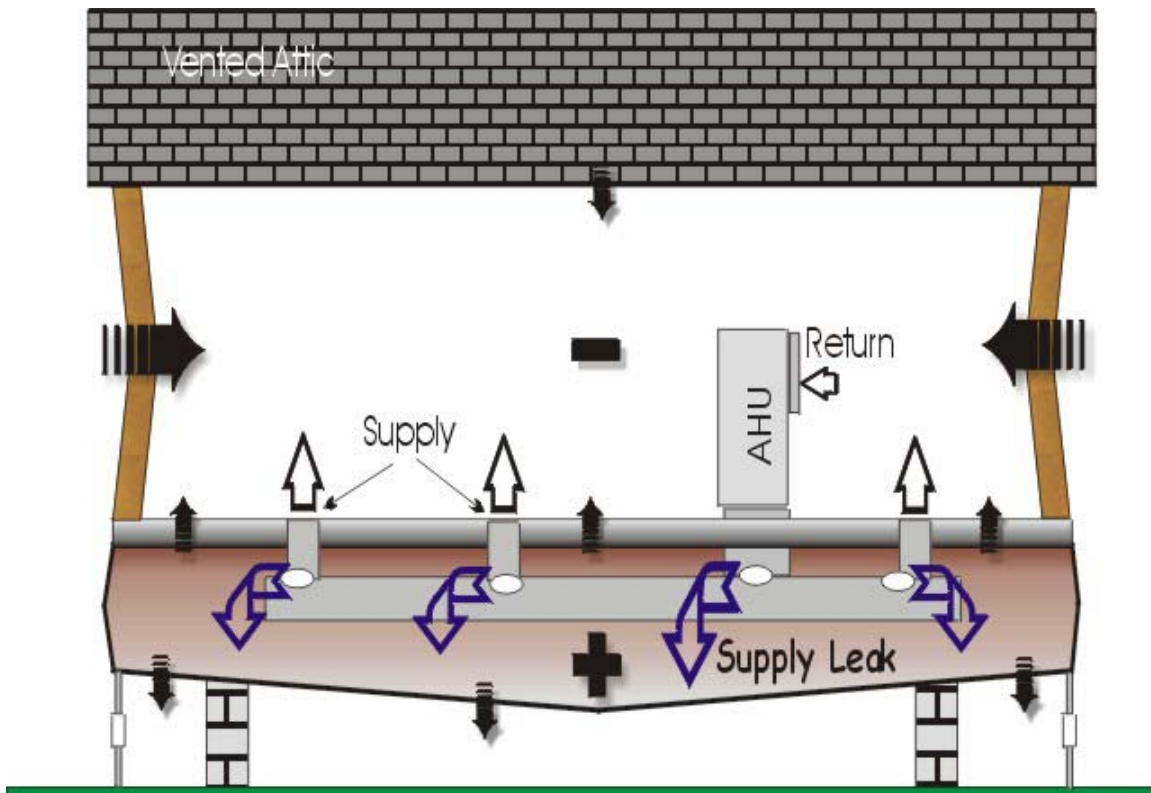
connection points in the duct work. When the AHU moves air, some of it leaks into the belly and eventually to the outside through tears in the belly board. This loss of air creates a negative pressure inside the house and a positive pressure in the belly as schematically shown in *figure 5*. The negative pressure draws outside or attic air into the house through the numerous cracks and crevices connecting the inside of the house to the outside or the attic. If this outside air is cold and dry, like it is in the wintertime in the Northern U.S. it will increase the heating energy use and occupant discomfort. This situation would not rot the home in this climate but it will in the hot, and humid Southern U.S..

Figure 5 A typical manufactured house with an inline floor supply system loses 10-30% of the air to the “belly” of the home. There are usually numerous holes, penetrations and tears in the “belly” board, which allows free air movement between the crawlspace and the “belly”. The loss of the supply air tends to depressurize the living space above.

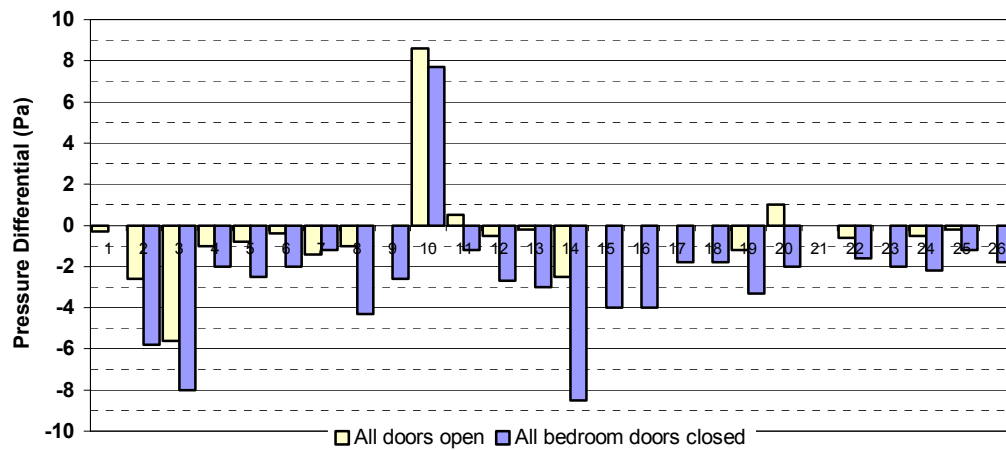
Figure 6 Pressure differential measured across the front door when the air handler fan is operating and all of the interior bedroom doors are open and then closed. The main body or area containing the central return experiences a negative pressure with reference to outside.

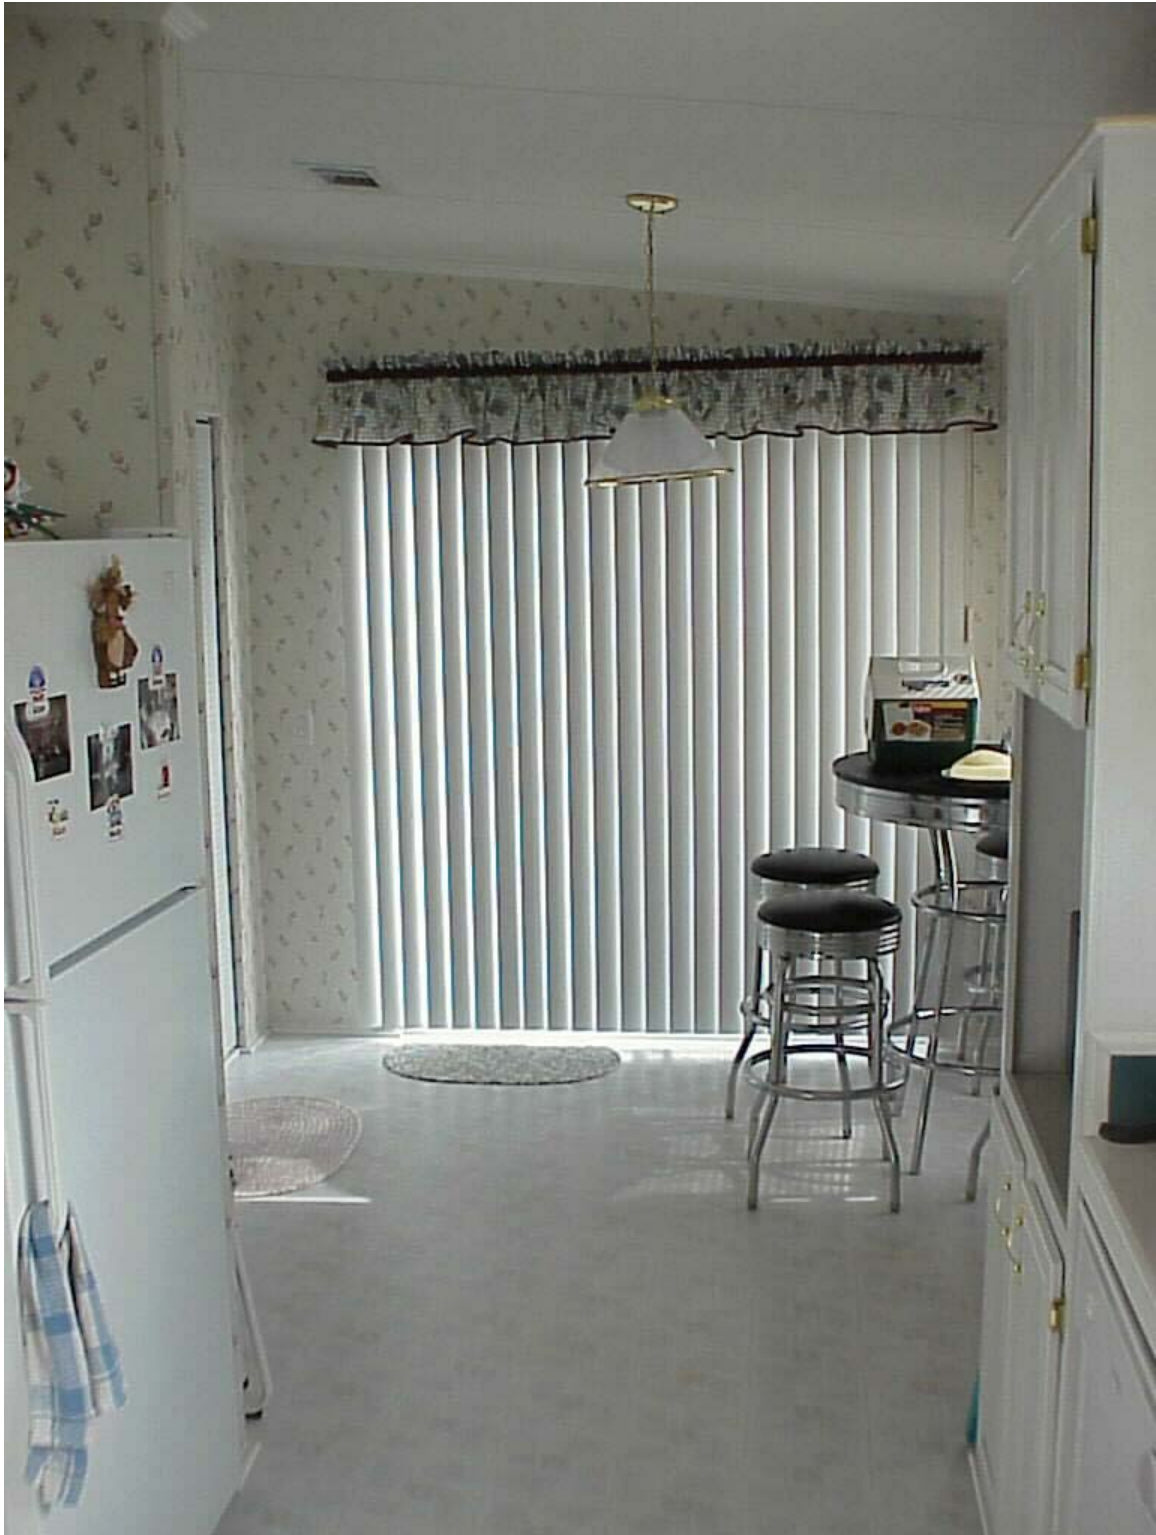
There appears to be a pattern of floor moisture/staining problems when the duct system is located overhead in the attic. Staining and warping of vinyl-covered floors has occurred in areas under the register. The areas of the vinyl covered flooring showing the worst staining were being washed by cold air from the supply registers (*figure 7 & 8*). Though measurements were not made of floor temperatures, it stands to reason that areas being washed by the supply air will tend to be cooler than those areas not washed. This cooling of the surfaces creates temperatures below the crawlspace dewpoint temperature and condensation occurs.

Figure 7 Breakfast nook with a vinyl floor covering and overhead supply register. Visible discoloration of the floor (pink spots) existed primarily in the area between the table and the cabinets on the right side of the picture. The supply register was oriented as to blow air to the outside wall.

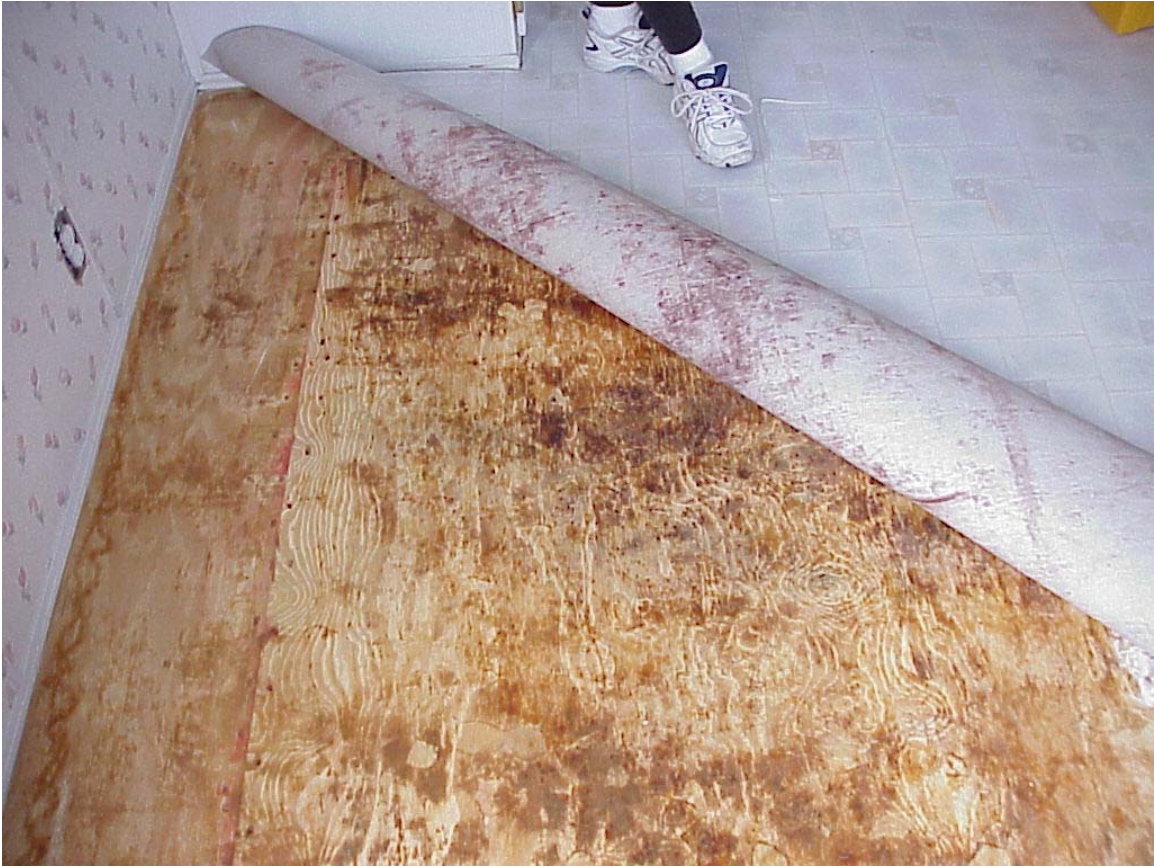
Figure 8 The floor covering has been partial removed. The plywood flooring was wet to the touch and staining exists on much of the under side of the vinyl. The floor decking was removed to inspect the underside – it appeared dry.
